NM Q.A.

台中榮總核醫科
周國堂放射師
2019/9/7

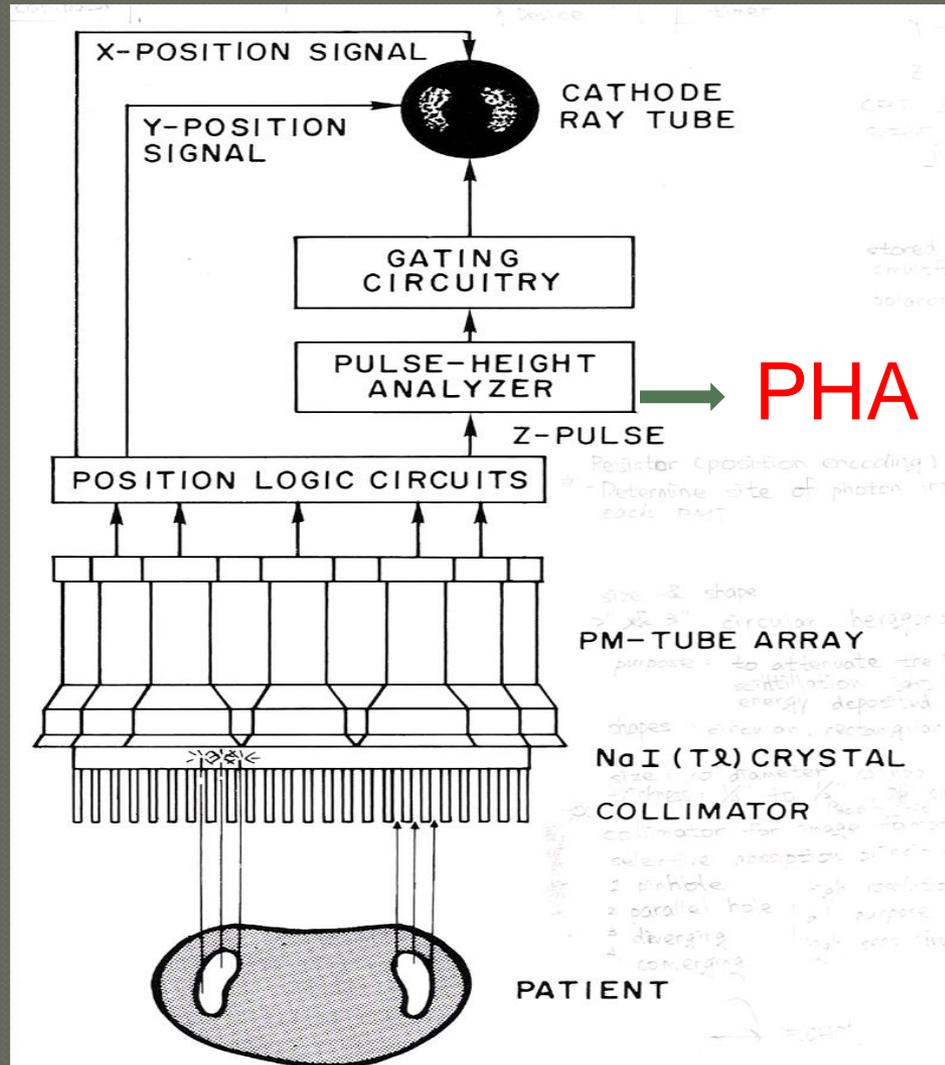
NaI閃爍偵檢器

- ◎ 分辨時間短及偵測效率高
- ◎ 閃爍體吸收能量後，會激發出電子
- ◎ 電子放出可見光
- ◎ 在**NaI**晶體內加入**Tl**，可增加可見光的產率

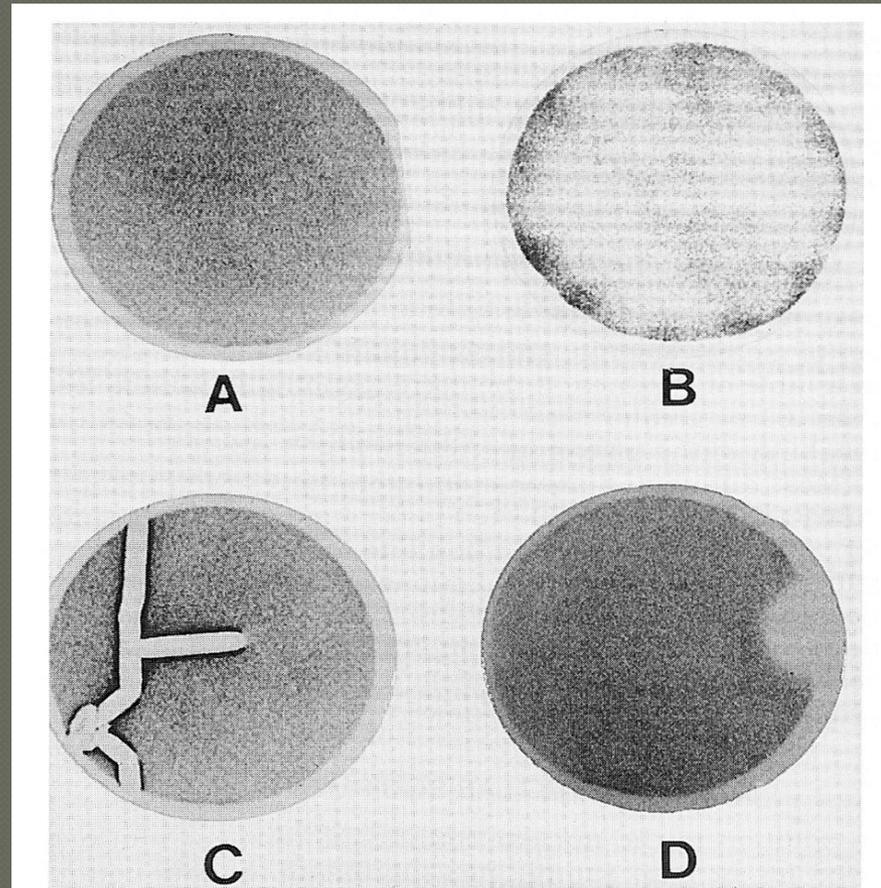
Flood images from a scintillation camera demonstrating (A) acceptable uniformity, (B) shift in high voltage, (C) broken crystal, and (D) nonfunctioning photomultiplier tube. (Reproduced by permission from Sandler MP, Patton JA, Partain CL, eds. *Thyroid and parathyroid imaging*. East Norwalk, CT: Appleton-Century-Crofts, 1986:83.)

- ◎ 使用有缺損的準直儀或選用不當之準直儀
- ◎ NaI晶體受潮，或受外力大力撞擊、溫度劇烈變化，使NaI晶體破裂
- ◎ 光電倍增管電路平衡系統故障、功能喪失，或光傳送效率降低
- ◎ 脈衝高度分析器選取不當之光子能峰

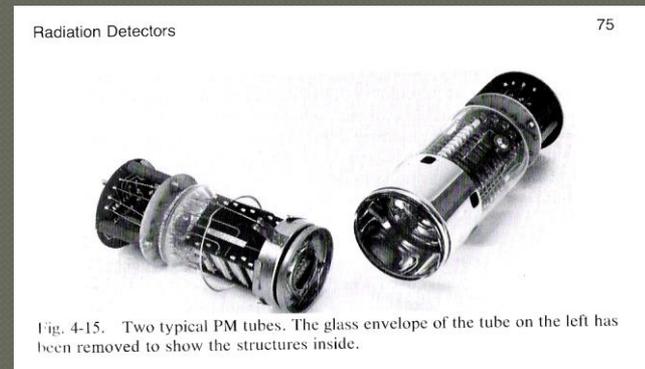
光電倍增管 (PM Tube)

- ◎ 光電倍增管主要是將閃爍脈衝所輸出微弱的光轉變成電子訊號，並大量的增加光電子的數目
- ◎ 晶體通常以矽化脂 (silicone grease) 與光電倍增管連接，以防止由於反射而損失光子

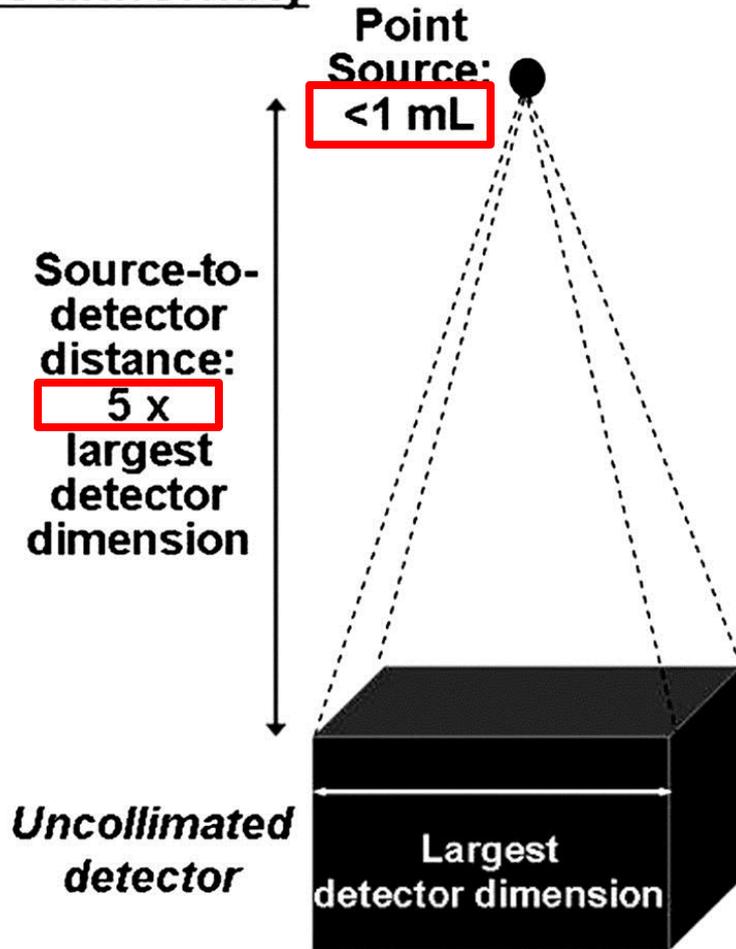
Intrinsic uniformity

- **Intrinsic Uniformity (without collimator)**
 - Solid plastic disk ^{57}Co
 - Fluid-filled sheet source container $^{99\text{m}}\text{Tc}$
 - Point source $^{99\text{m}}\text{Tc}$**
- 1-3 million-count image

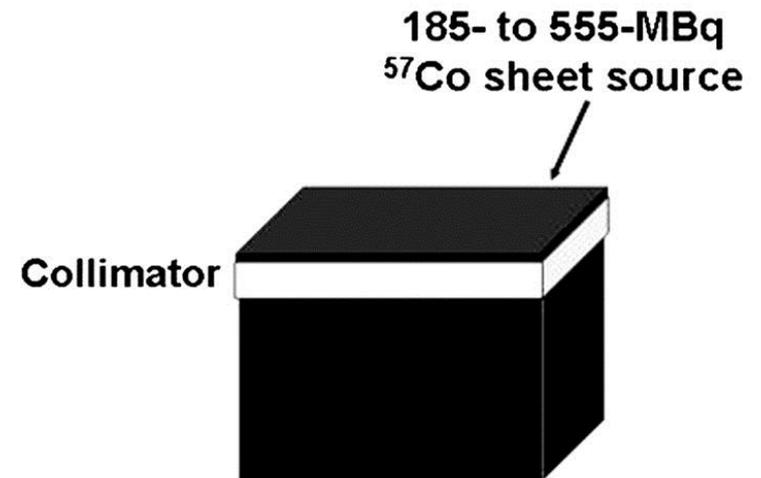
Extrinsic uniformity

- Imperfections (瑕疵) :
collimators 、 variations in crystal
response 、 differences among PM tubes 、
fluctuations in the electrical circuitry ◦
- Extrinsic Uniformity (with collimator)
Solid plastic disk ex. ^{57}Co
Fluid-filled sheet source container ex. TC

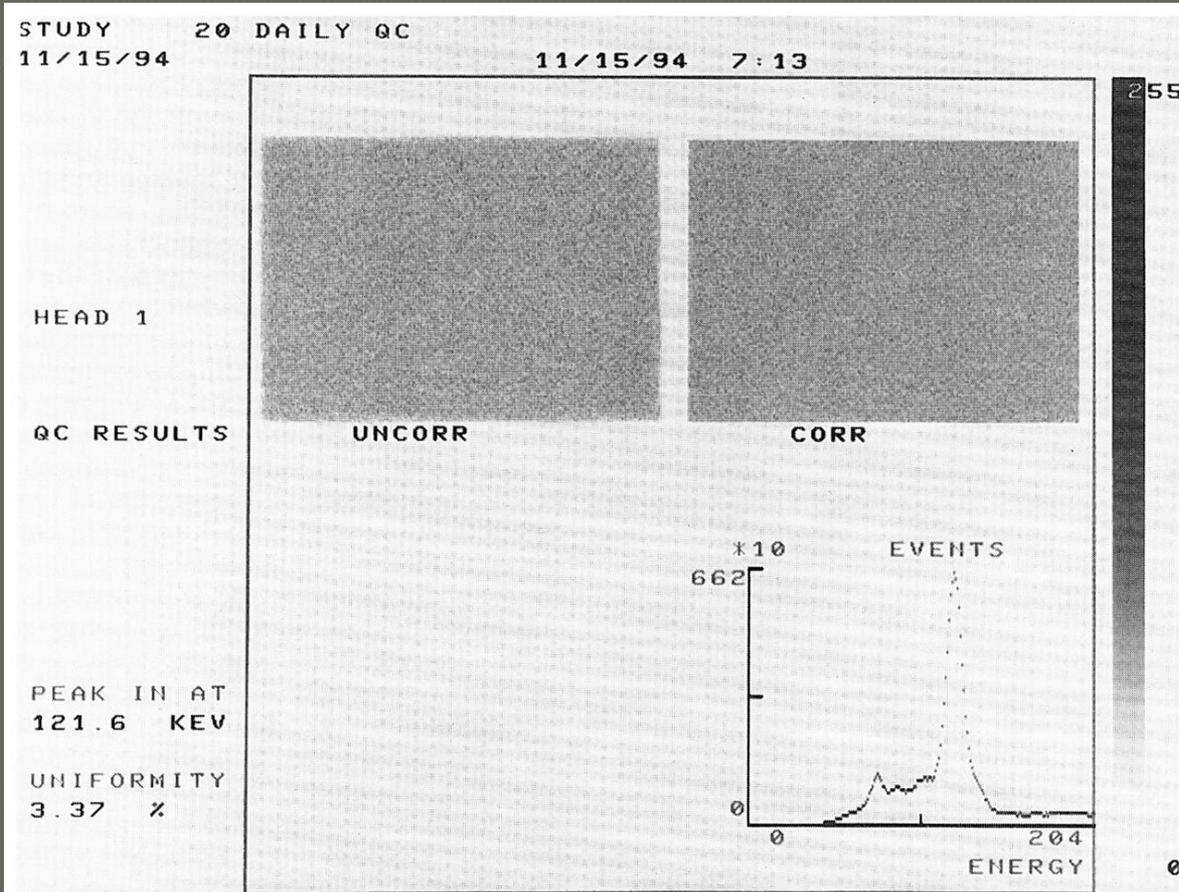
Quality control report from a digital scintillation camera showing an energy spectrum from ^{57}Co , the position of the photopeak, a flood from the collimated camera obtained with a plane source of ^{57}Co before and after uniformity correction, and the results of a calculation of integral uniformity.

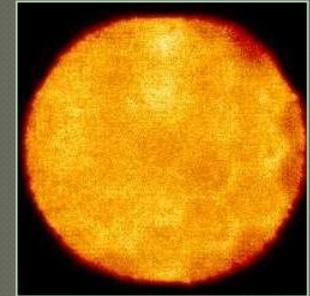
校正前

校正後

照野內計數的最大偏差： $\text{Integral uniformity} = (\text{max}-\text{min})/(\text{max}+\text{min}) \times 100\% (\leq 5\%)$

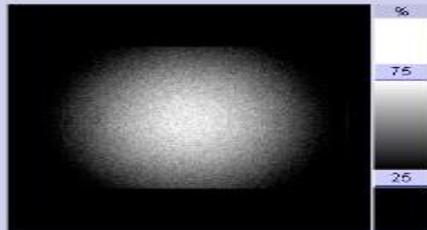
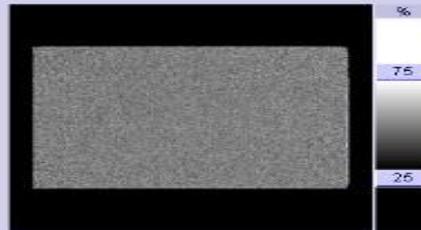
Detector 1

Acquired Flood

Curvature Corrected Flood

Uniformity	Central FOV	Useful FOV
	Integral: 1.64 %	2.04 %
Differential: 1.30 %	1.30 %

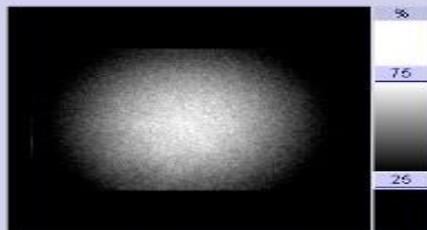
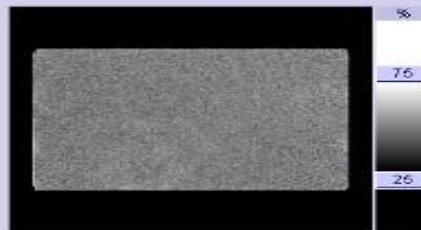
Detector 2

Acquired Flood

Curvature Corrected Flood

Uniformity	Central FOV	Useful FOV
	Integral: 2.73 %	2.85 %
Differential: 1.77 %	1.97 %

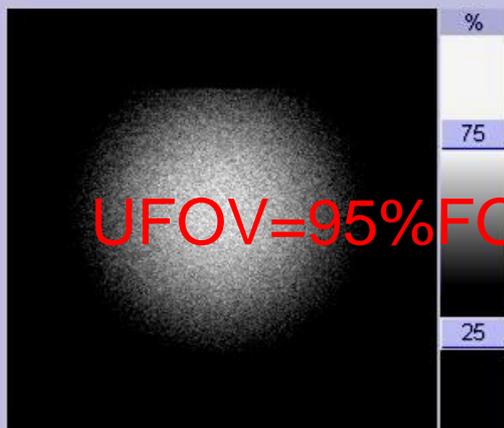
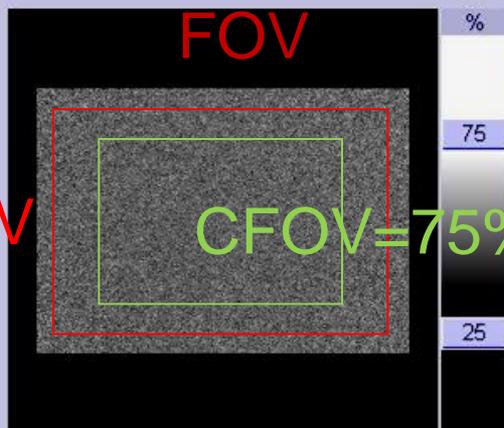
Detector 1

Acquired Flood

Curvature Corrected Flood

UFOV=95%FOV

CFOV=75%UFOV

Integral: 1.53 % 1.70 %

$IU = (Max - Min) / (Max + Min) * 100$
Max is the Maximum and Min is the Minimum pixel value in a pixels.

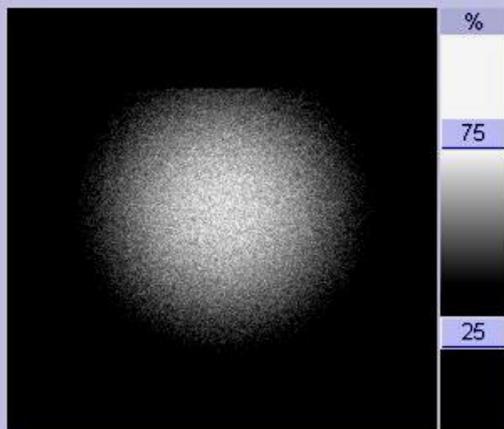
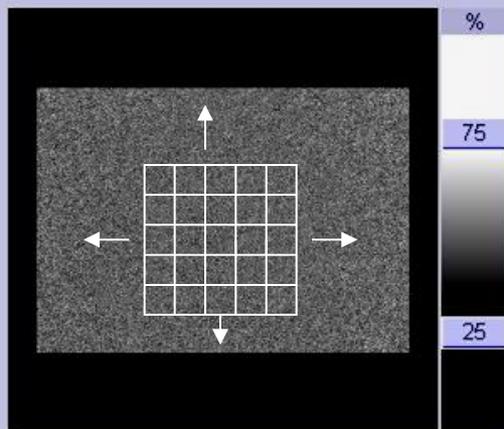
Detector 2

Acquired Flood

Curvature Corrected Flood

Differential: 1.22 % 1.60 %

$DU = (Hi - Low) / (Hi + Low) * 100$
Hi is the highest and Low is the lowest pixel value in a row of 5 pixels.

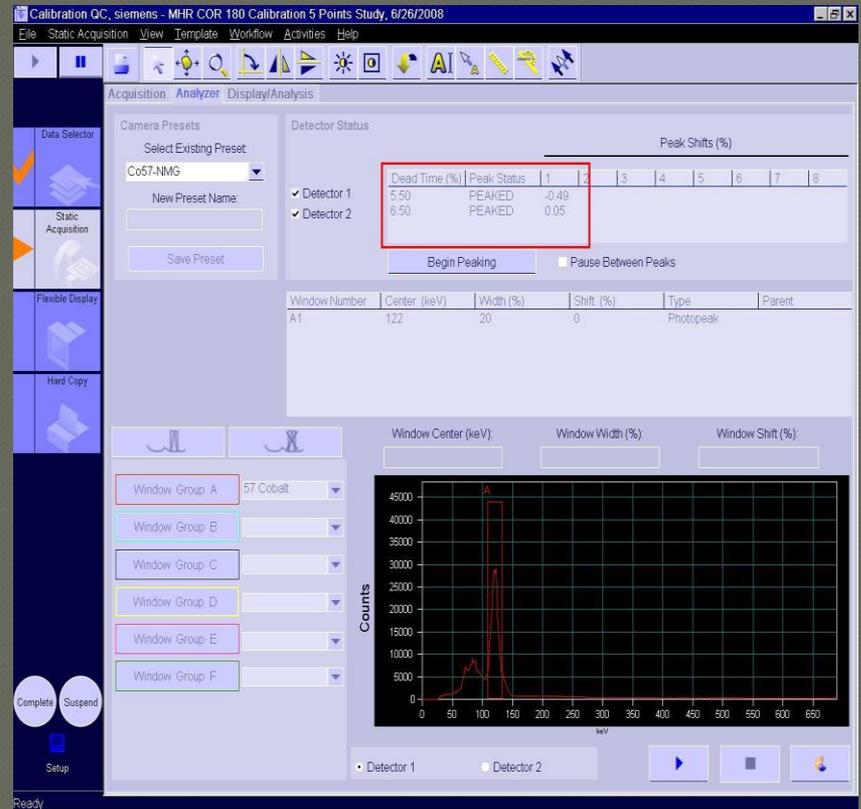
Peaking

- 調整個別的 PM tube gains，以使得不同區域之閃爍晶體所產生的 photopeak 其較大或較小部分能夠被包含在 PHA window 內，如此可調整偵測效率以補償影像的非均勻性。

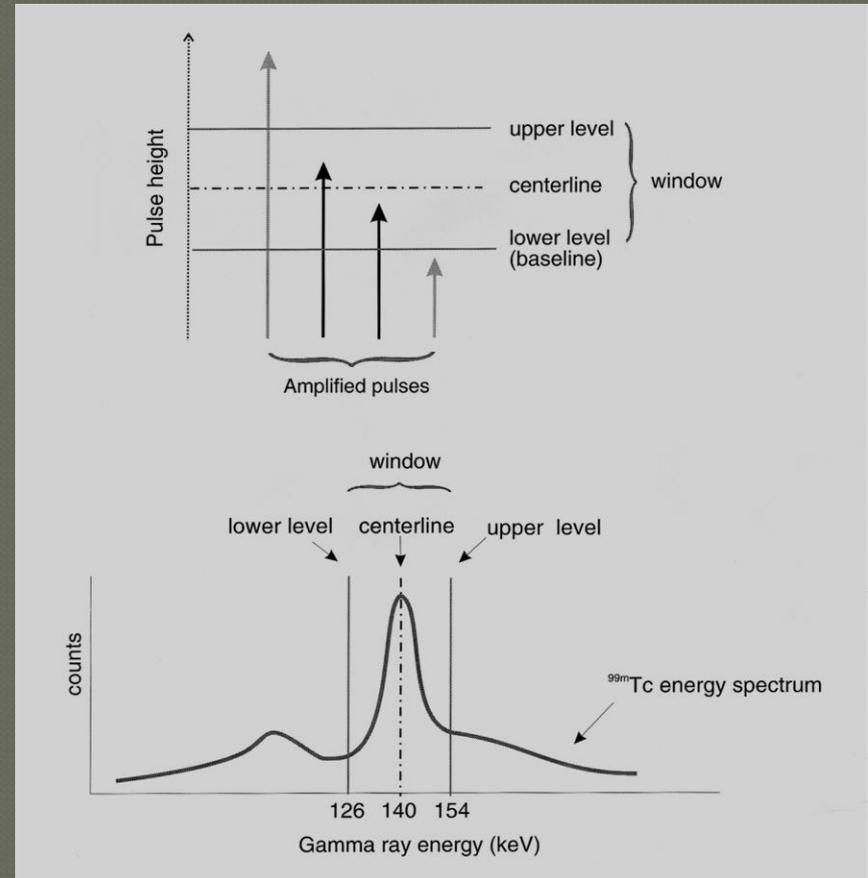
Planar (Photopeak)

- Pulse-Height-Analyzer
- Window of photon energies
- Methods
- Narrow window –
- increases resolution but
- decreases sensitivity

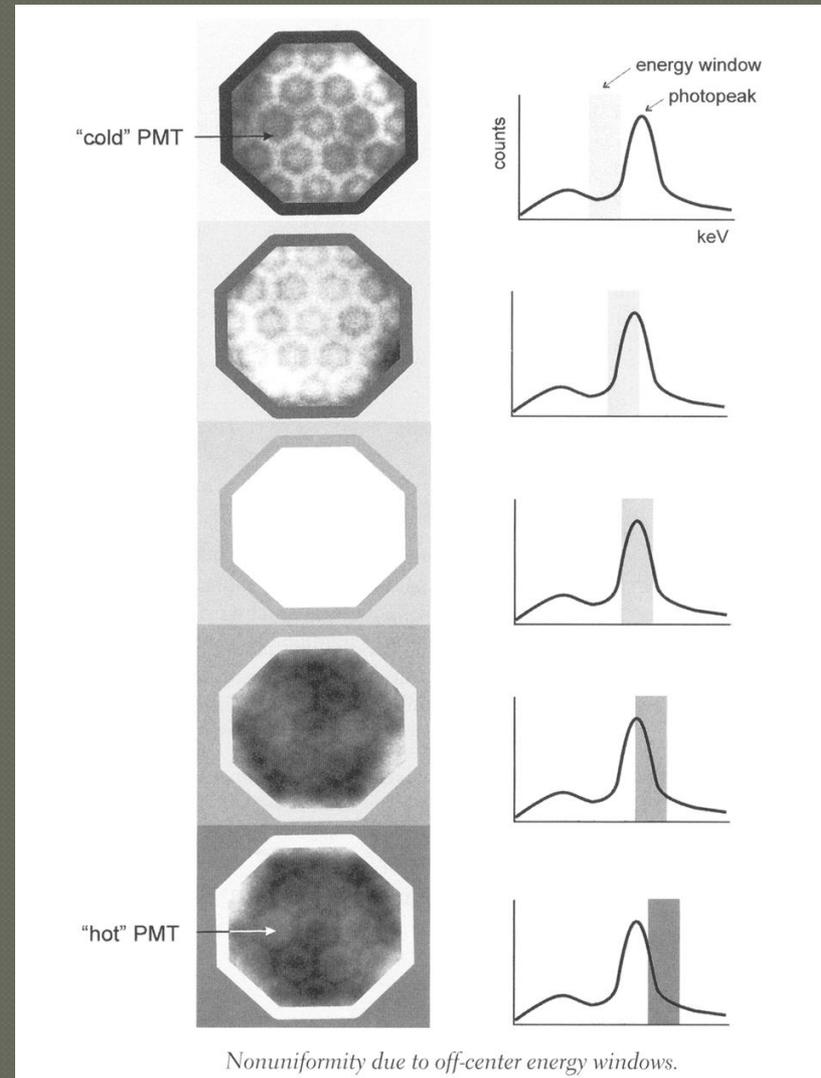
Unstable energy window setting

- Drift of the **energy windows** away from the peak will lead to significant artifacts in images. In some of the older cameras, off-center windows will yield relatively **“hot”** or **“cold”** photomultiplier defects on the daily uniformity floods.

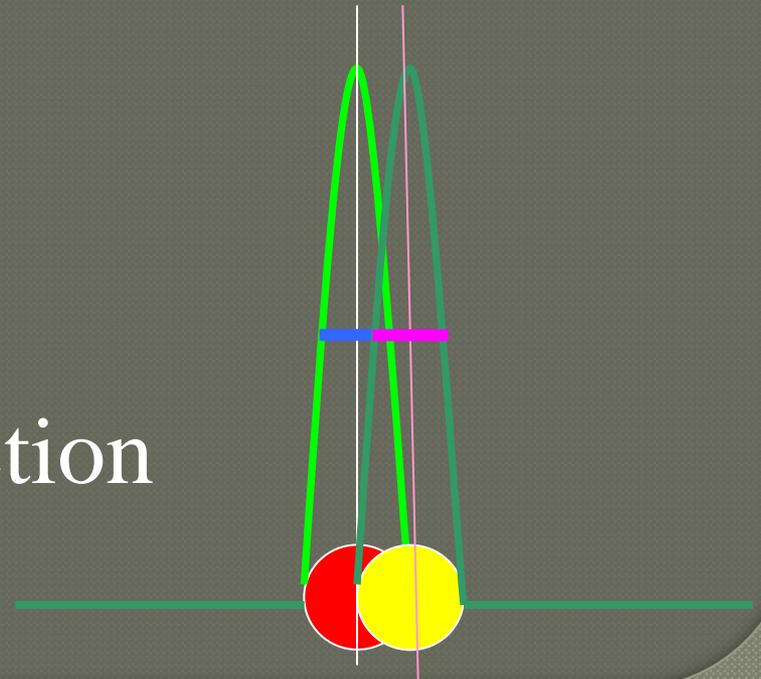
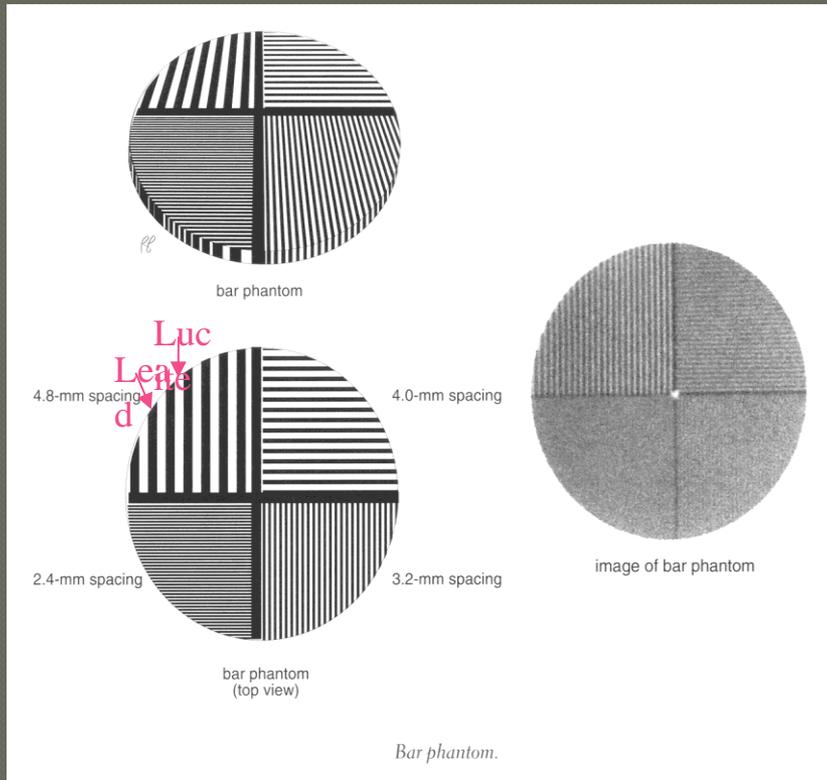
- Phantom – **Bar phantom**
- Flood source
- Distance
- Weekly
- Line or point spread function

- The resolution of the imaging system is evaluated visually by imaging a bar phantom

The intervals illustrated in figure above are hypothetical but representative of a standard configuration.

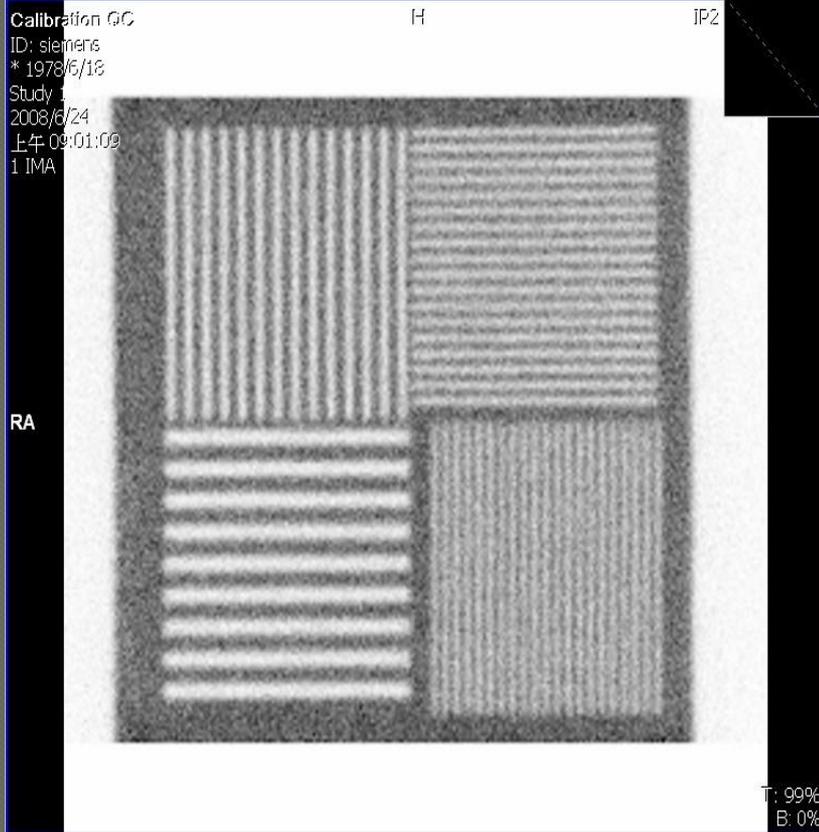
System Spatial Resolution with and without Scatter

Calibration QC
ID: siemens
Spatial Resolution Test 6/24/2008
Study 1
Spatial Resolution Test 6/24/2008

Head 1 (Head Out) 2002K Duration: 103sec: 256x256
Pic1: 8mm 57-Cobalt

Head 1 (Head 90) 2002K Duration: 103sec: 256x256
Pic1: 8mm 57-Cobalt

Head 1 (Head out, Phantom Rot 50) 2002K
Duration: 103sec: 256x256 Pic1: 8mm 57-Cobalt

Head 2 (Head out) 2011K Duration: 103sec: 256x256
Pic1: 8mm 57-Cobalt

Head 2 (Head 90) 2011K Duration: 103sec: 256x256
Pic1: 8mm 57-Cobalt

Head 2 (Head out Phantom Rot 68) 2011K
Duration: 103sec: 256x256 Pic1: 8mm 57-Cobalt

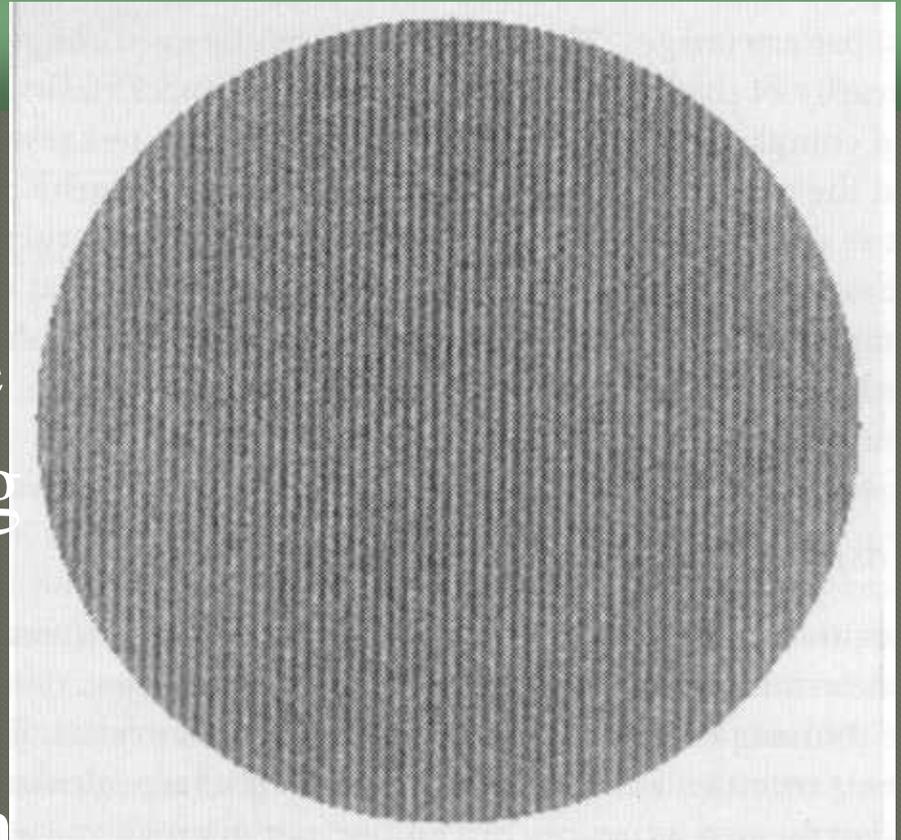
- Linearity of the gamma camera image is tested by examining the image of the **bar phantom**
- Straight and unbroken

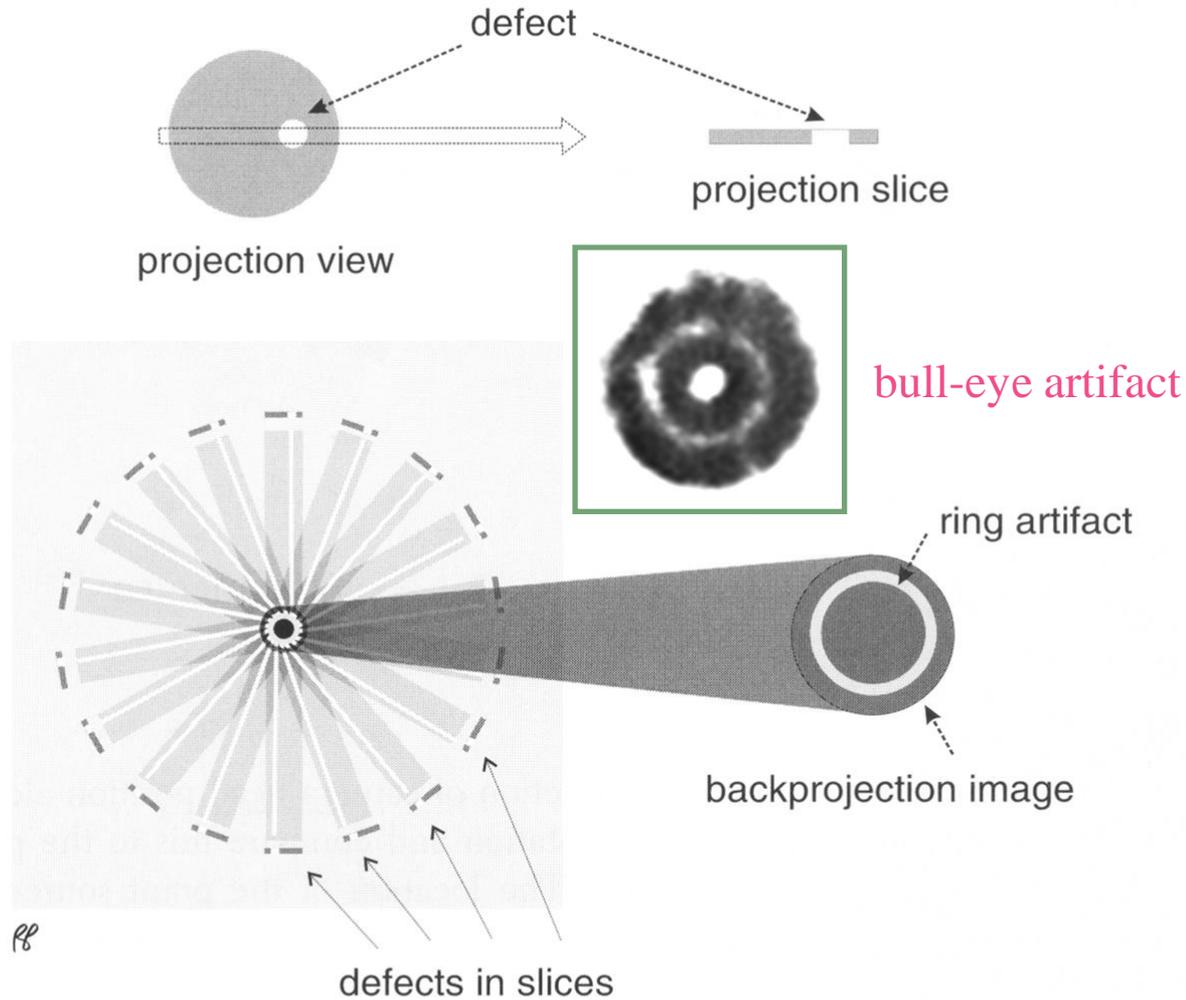
- SPECT images are degraded by small degrees of **nonuniformity** in the flood field that do not adversely affect **planar images**.
- During backprojection, relatively minor defects will become **quite prominent** and sometimes appear as **ring artifacts** in the reconstructed transaxial slices.

Ring artifact created during backprojection of an area of nonuniformity.

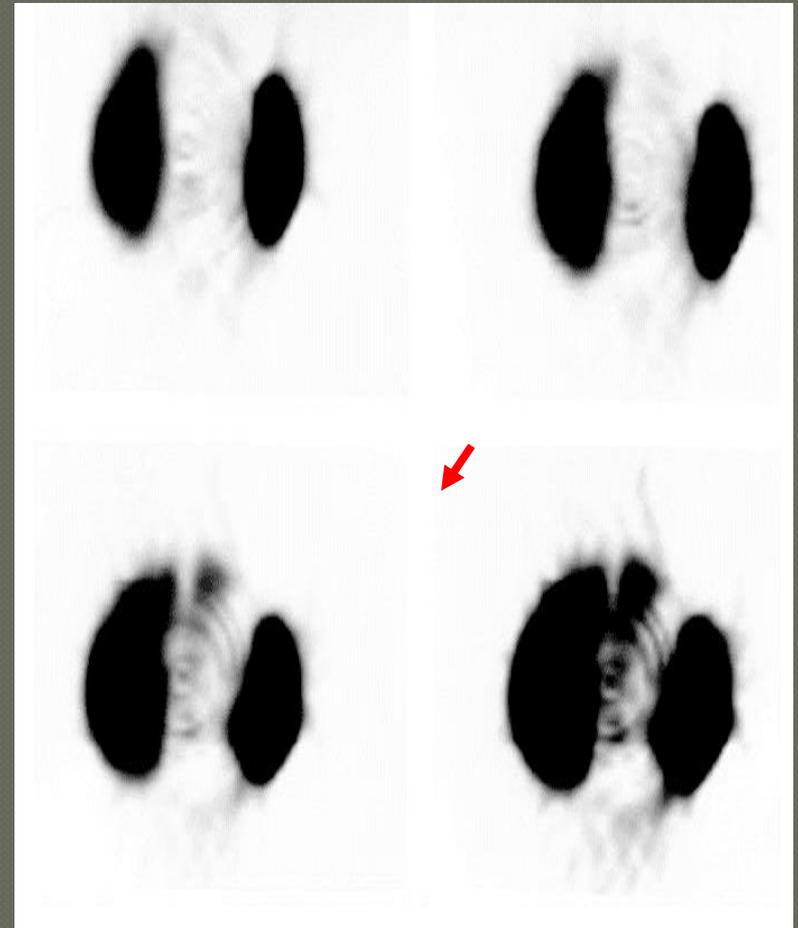
Bullseye Ring Artifact- nonuniformity

- SPECT image through 20-cm diameter ^{99m}Tc -filled cylinder phantom resulting from gross γ -camera nonuniformity Severe ring, or bull's-eye, artifact in transverse

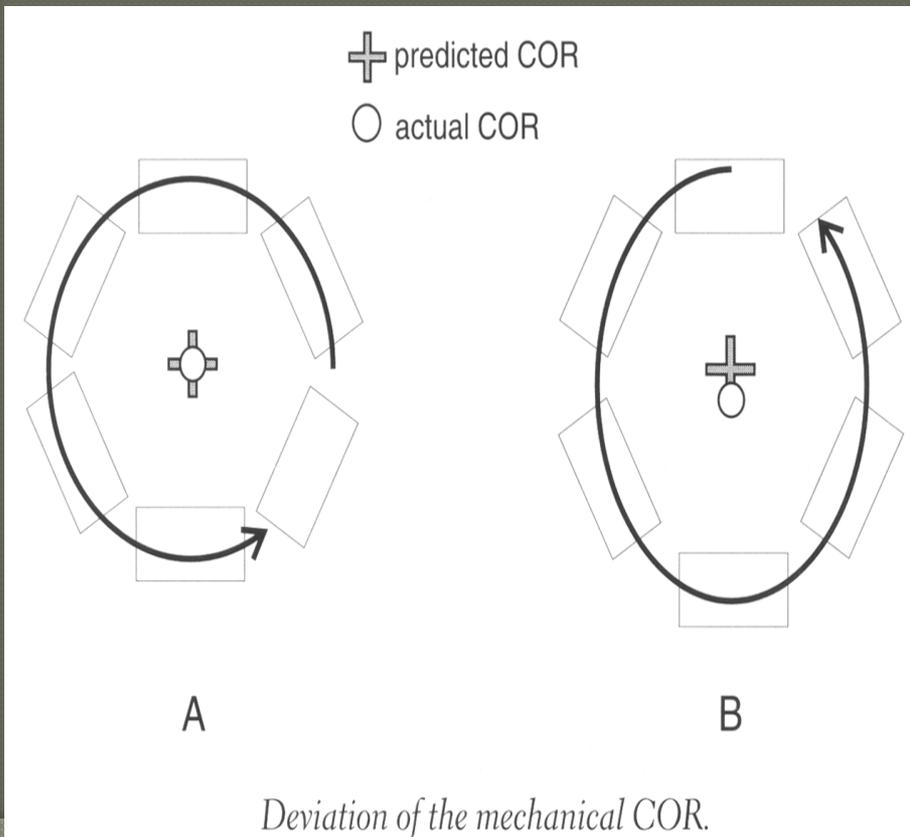
- ❖ The most common cause of true shift of the COR is electronic malfunction.
- ❖ Mechanical problems, such as the use of a **collimator that is too heavy** for the gantry, are less common.

The test for a stable COR consists of placing a **point source** of **Tc-99m** slightly off center on the patient bed. Projection views are obtained over a 360° arc.

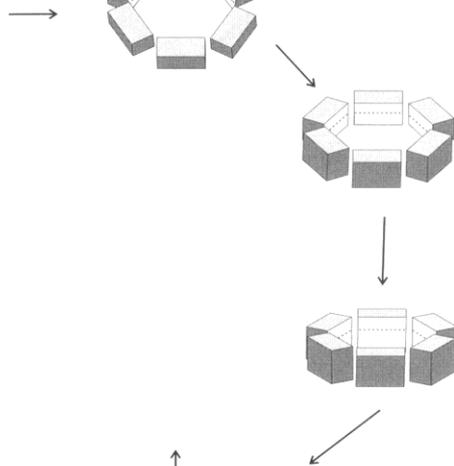
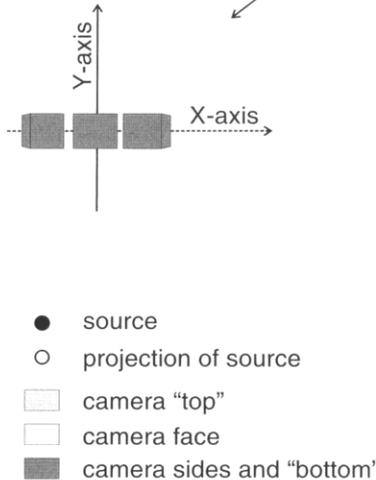
COR curves in the x direction.

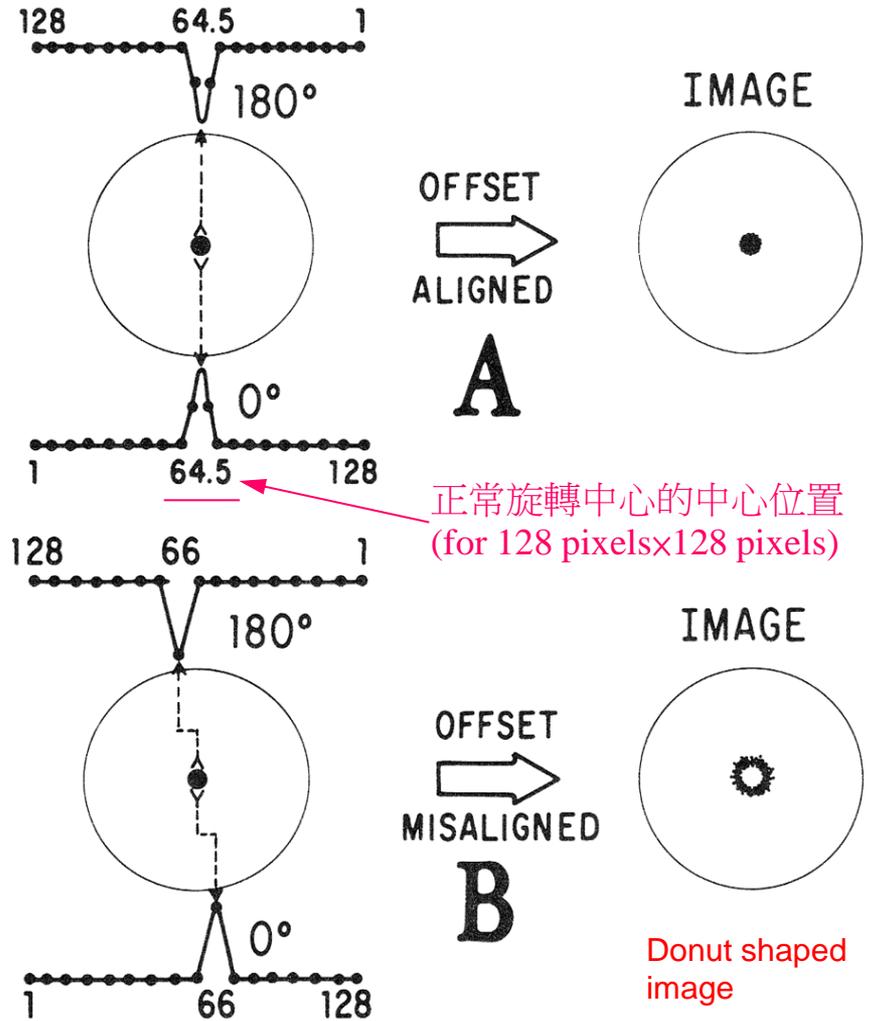
Effect of misalignment of the mechanical axis-of-rotation with the reconstruction axis-of-rotation. Very small misalignment errors result in loss of spatial resolution. For larger errors, images of point sources have a "ring"-type appearance.

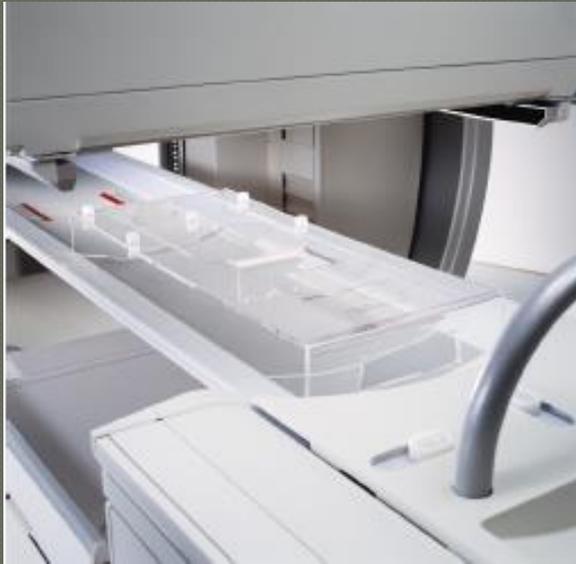
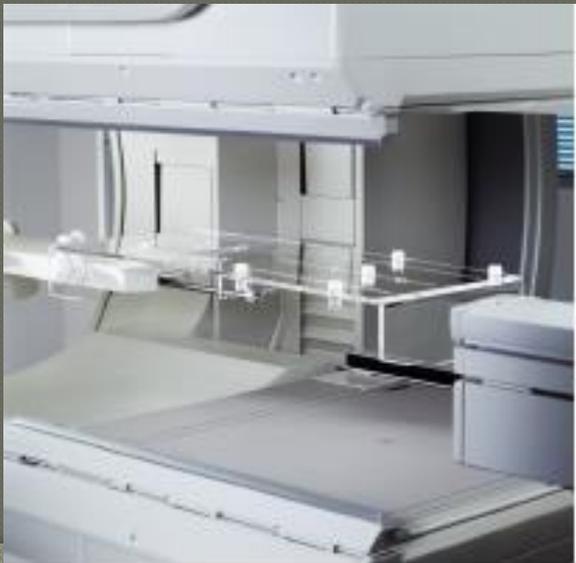
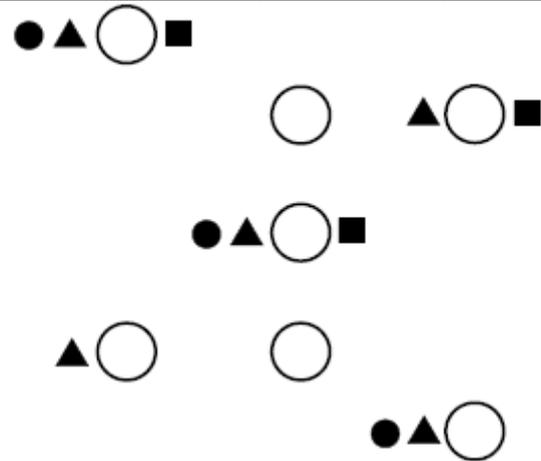
Fig. 12: MHR Phantom Source Placement

Source Location

- Extra High Energy Collimator
- ▲ UHR, HRES, LEAP & Fanbeam Collimator
- All Others

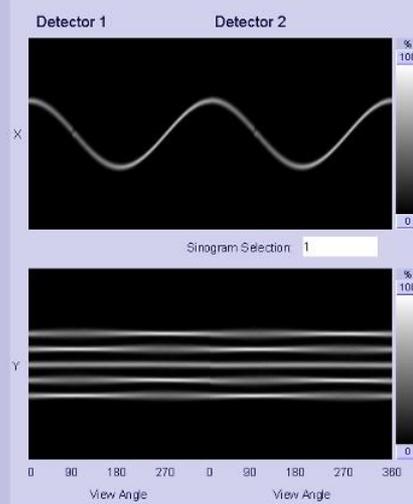
Head Alignment Calibration

Detector 1	
Center Of Rotation:	-1.150 mm
Axial Shift:	0.544 mm
Back Projection Angle:	45.048 deg
System Resolution At 20cm:	17.072 mm
Principal Ray:	mm
Focal Length:	mm

Detector 2	
Center Of Rotation:	0.550 mm
Axial Shift:	-0.544 mm
Back Projection Angle:	-45.048 deg
System Resolution At 20cm:	17.276 mm
Principal Ray:	mm
Focal Length:	mm

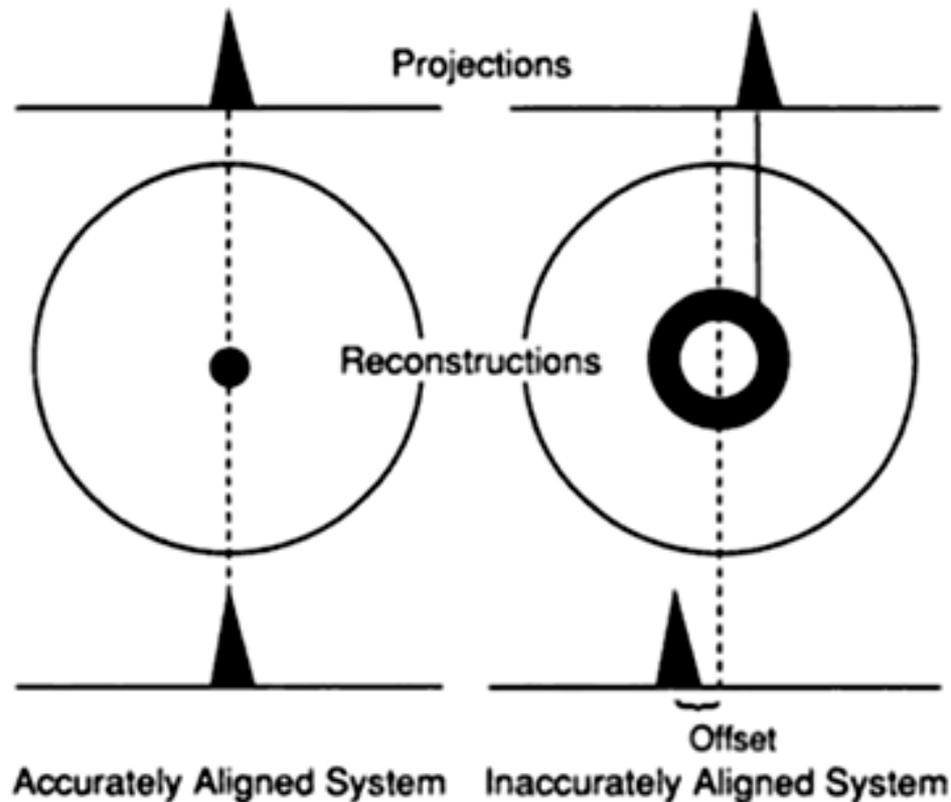
Donut shaped image

FIG. 12.11. An illustration of the effect of a misaligned center of rotation. A "donut" shaped image appears from inaccurately aligned center of rotation. (From Todd

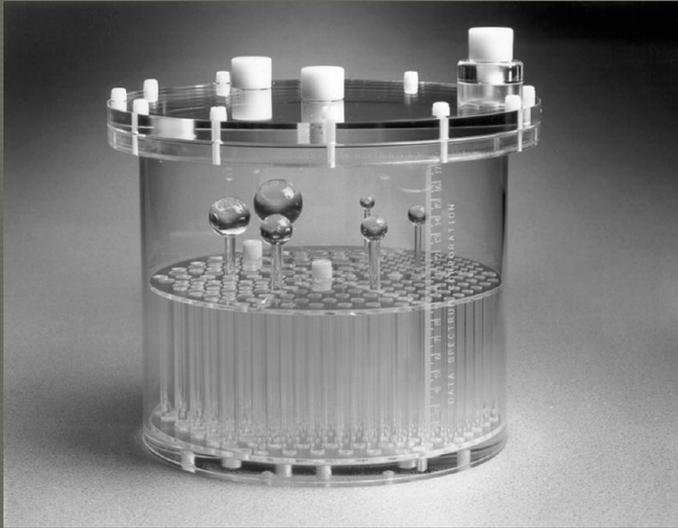
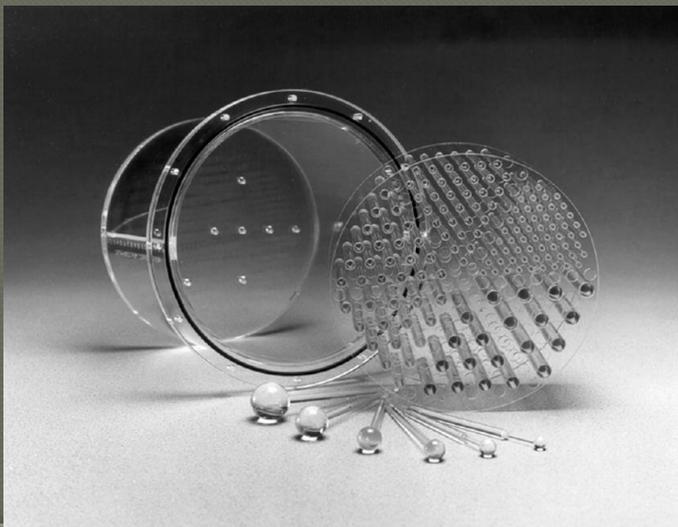
Jaszczak Phantom

- For use with SPECT and PET systems
- System performance evaluation (collimator, artifacts, calibration, reconstruction parameters)
- Acceptance testing
- Routine quality, assurance and control
- Evaluation of center-of-rotation error
- Evaluation of non-uniformity artifact
- Evaluation of changes of radius-of-rotation on spatial resolution
- Evaluation of reconstruction filters on spatial resolution
- Evaluation of attenuation and scatter compensation
- Research

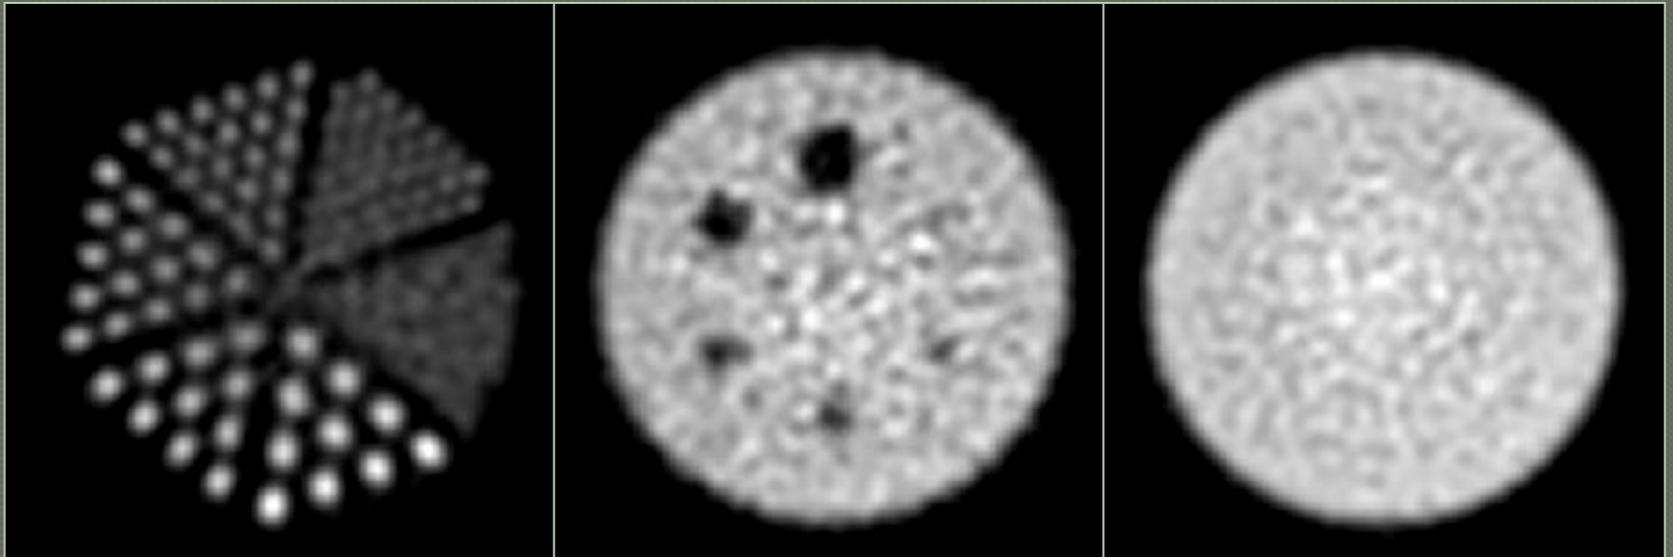
Jaszczak Phantom

- SPECT phantoms - **cylindrical lucite containers** - different sized **rods, cylinders spheres**
The container - filled with water containing a small amount of radioactivity (^{99m}Tc)
- **Monthly** and the images assessed for degradation in resolution
- **Uniformity**

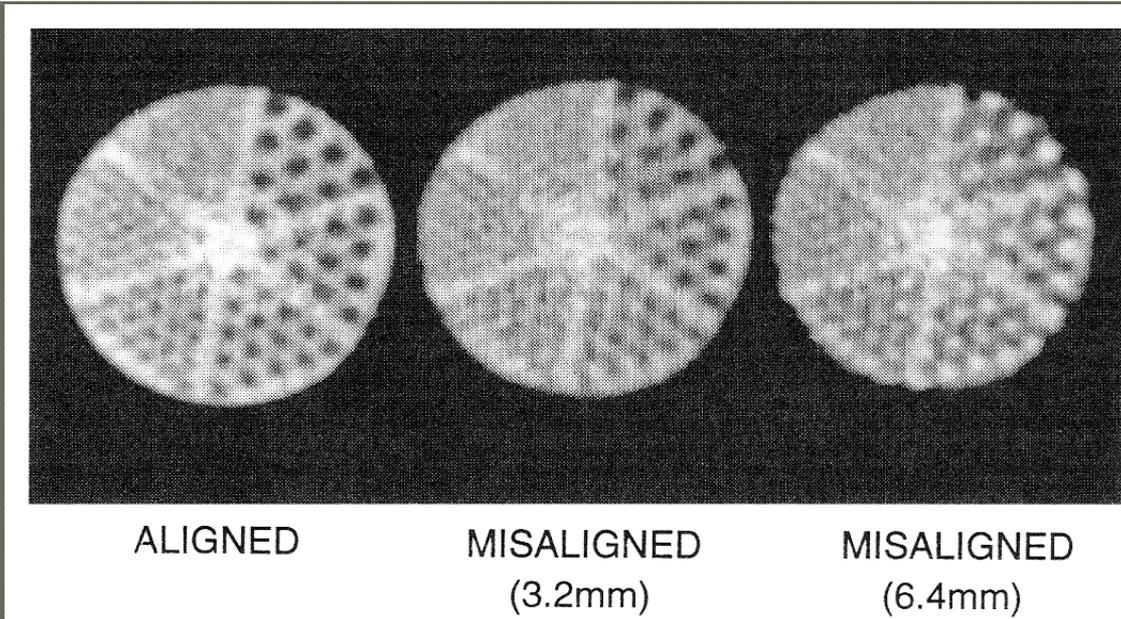
Effect of center-of-rotation errors on SPECT images of a cold rod phantom. With large errors, the appearance of the rods is distorted. Even with small misalignment, image quality is degraded.

COR 偏離 0.5 個像素以上會造成影像品質變差
